# Hobson Manufacturing Corp. v. SE/Z Const. Clerk's Record v. 6 Dckt. 38202

This cause involved the various contract-based claims of the parties arising from the agreement between Defendant SE/Z Construction, LLC ("SE/Z") and Defendant/Counter Cross-Claimant State of Idaho ("State") for the construction of a BSL-3 laboratory in Boise (the "Project").

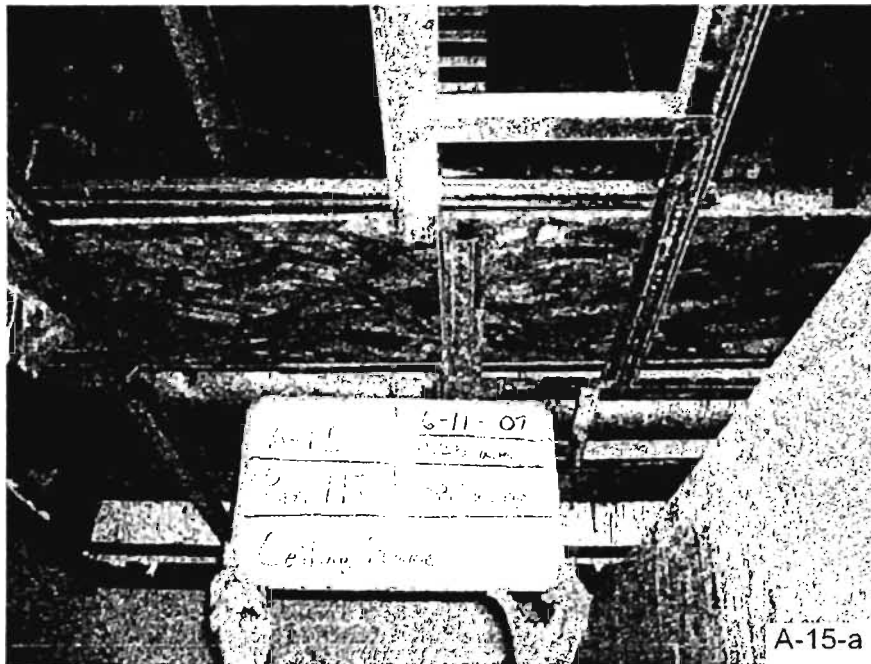
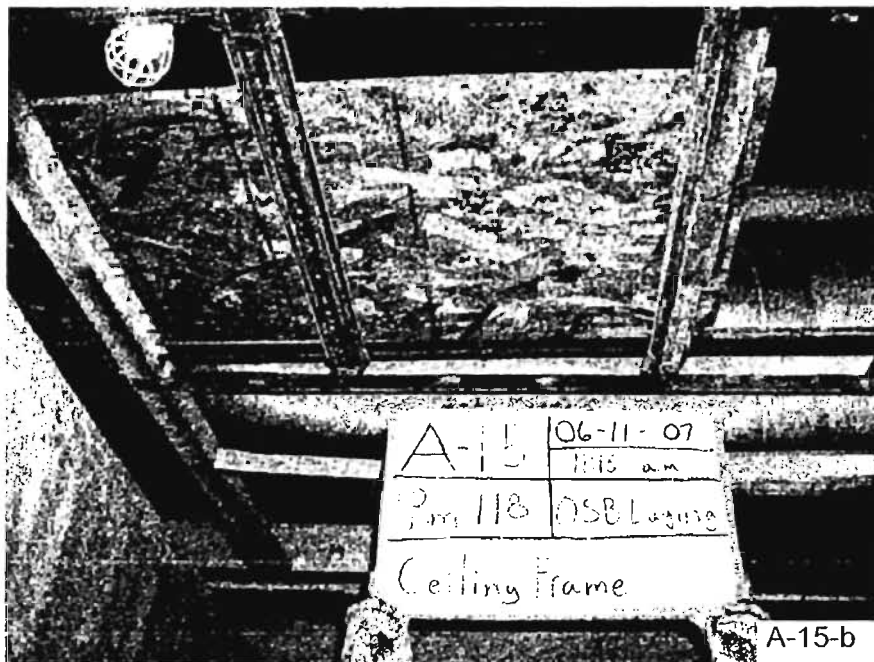
Location:	Bio Safety Lab #3	Originator:	S. Dean
Reference (i.e. RFI/CCD):	N/A	Date:	8/22/07
Specification Reference:	Specification Section 09255	Drawing Reference:	N/A
<b>NONCONFORMANCE DESCRIPTION</b>			
<p>Requirement:</p> <p>1) Suspended gypsum board ceiling to be installed per Specification Section 09255, page 3, 2.2 and page 8, 3.4.</p>			
<p>Deficiency:</p> <p>Suspended gypsum ceiling was not installed as required by the Specifications noted above.</p> <p>Attachments: Photographs A-15-a and A-15-b (partial sheet of OSB board used to stabilize ceiling components in BAC-T Virology Lab Room# 117 and TB/Mycology Lab Room# 118); A-15-c and A-15-d (pine 2"x4" board used to support hat channels in lieu of steel furring; steel furring channels specified do not exist in Clinical Sample Storage Room# 107); A-15-e (edge framing is light gauge metal and not steel furring; spacer used is aluminum section in Shower Room# 112); A-15-f, A-15-g and A-15-g1 (hat channel is again tied to steel support member in Shower Room# 112 which will not allow 'flat' ceiling installation); A-15-h and A-15-h1 (another photograph of the hat channel being tied to the steel furring channel in Shower Room# 112); A-15-i and A15-j (wire tied around hat channel to steel furring channel in BAC-T Virology Lab Room# 117); A-15-k and A-15-k1 (wire tied around hat channel and furring member in TB/Mycology Lab Room# 118); A-15-l and A15-m (lack of steel furring channels, improper edge angle, and improper framing around light fixture openings in BSL-3 Primary Procedures Room# 113 and BAC-T Virology Lab Room# 117 respectively); A-15-p, A-15-q, A-15-r, A-15-s, A-15-t, and A-15-u (indicates global lack of steel support channels and light gauge framing around fixtures in ceiling framing).</p>

Photos 'a' and 'b': OSB (plywood) was laid directly on the ceiling frame and hat channel was screwed in place to it.

RECOMMENDED DISPOSITION						
REWORK	X	SCRAP	USE-AS-IS	REPAIR	CONDITIONAL RELEASE *	
<p>Remove the ceiling and its non-compliant support structure in its entirety. After completion of mechanical work above ceiling, including repair work required on supply ductwork systems to eliminate excessive leakage and reinsulation, relocation of plumbing water hammer arrestors, and installation and leak testing of new stainless steel exhaust duct systems, install new ceiling support grid and gypsum board ceilings in compliance with specification section 09255. Coordinate installation with light fixtures and ceiling access panel locations to ensure proper installation as specified in section 09255.</p> <p>Wash. Gr. Representative: _____ Date: _____</p>						
DISPOSITION APPROVAL

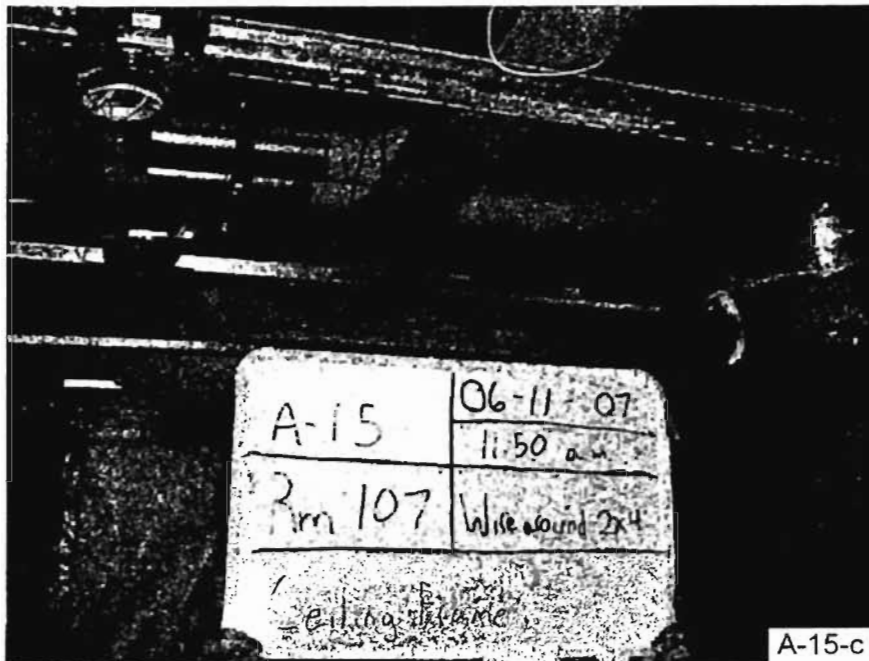
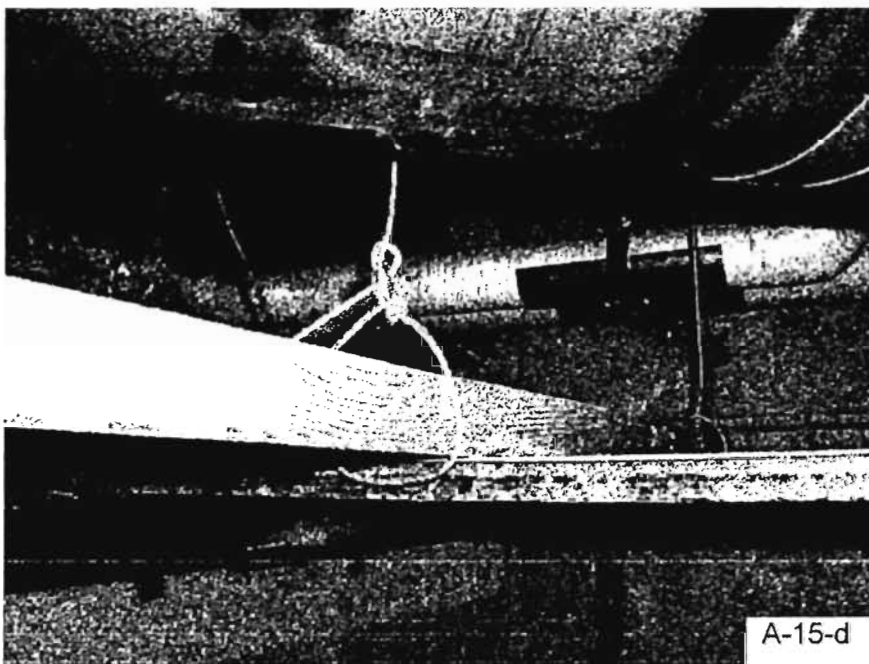
Photos 'c' and 'd': A wire was tied around a non rated two-by-four to support the ceiling framing (hat channel was screwed to wood 2X4).

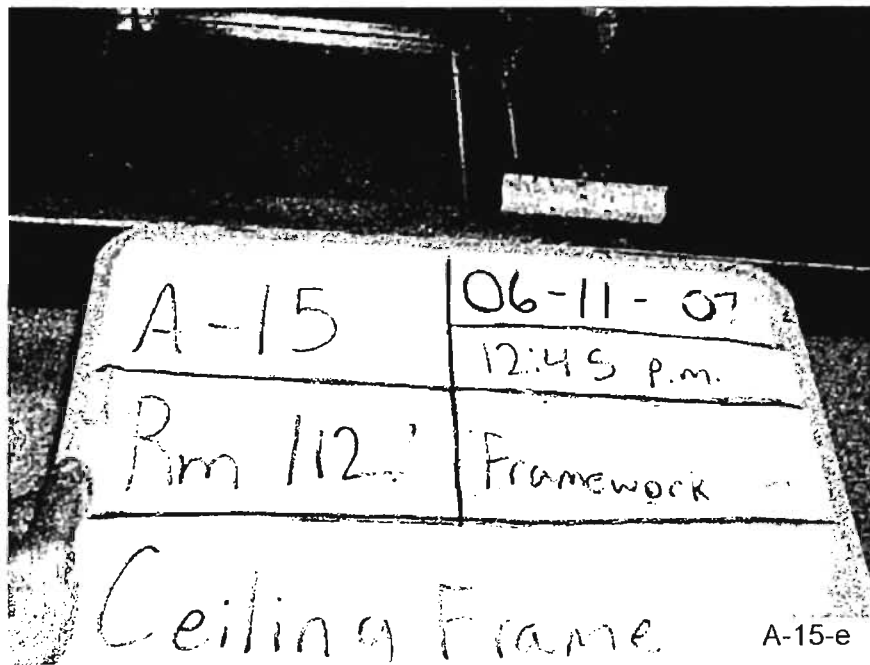
Photos 'e' and 'f': Wire was tied around the support framing hat channel which led to a 'wavy/uneven' sheetrock installation on the ceilings.

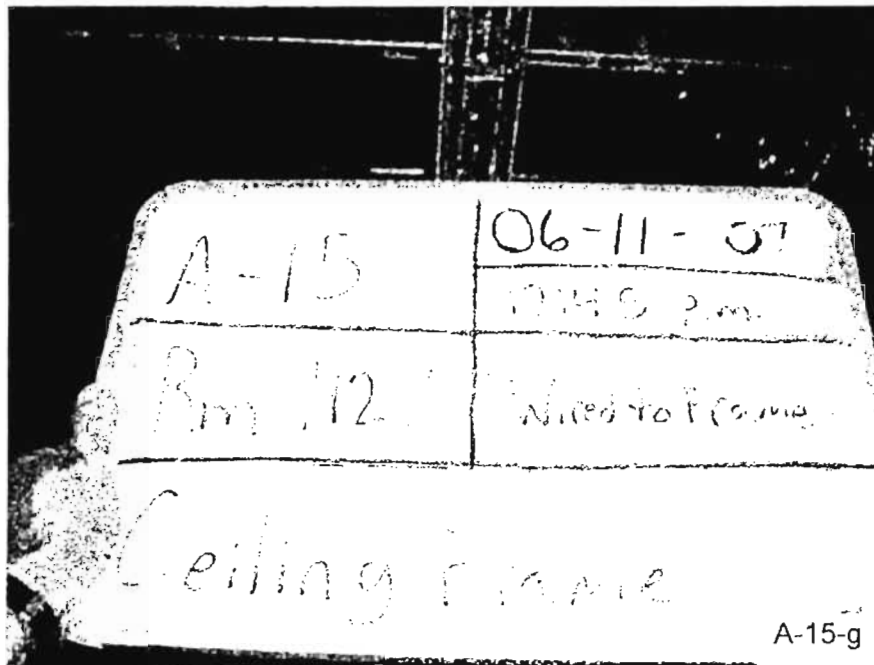
Photos 'g' and 'g1': Wire was tied around the support framing channel which led to a 'wavy/uneven' sheetrock installation on the ceilings. The close-up 'g1' shows a detail of the wire.

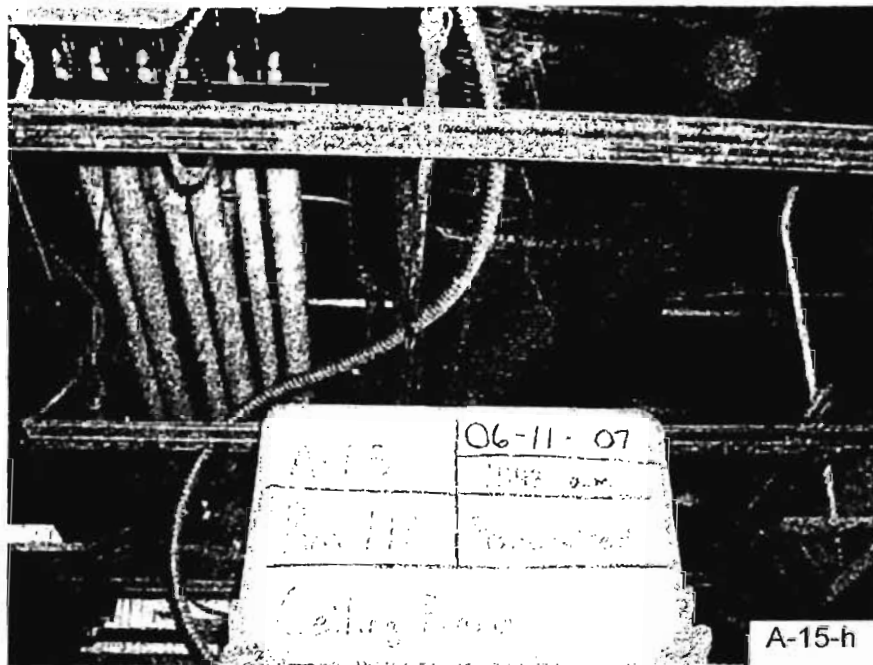
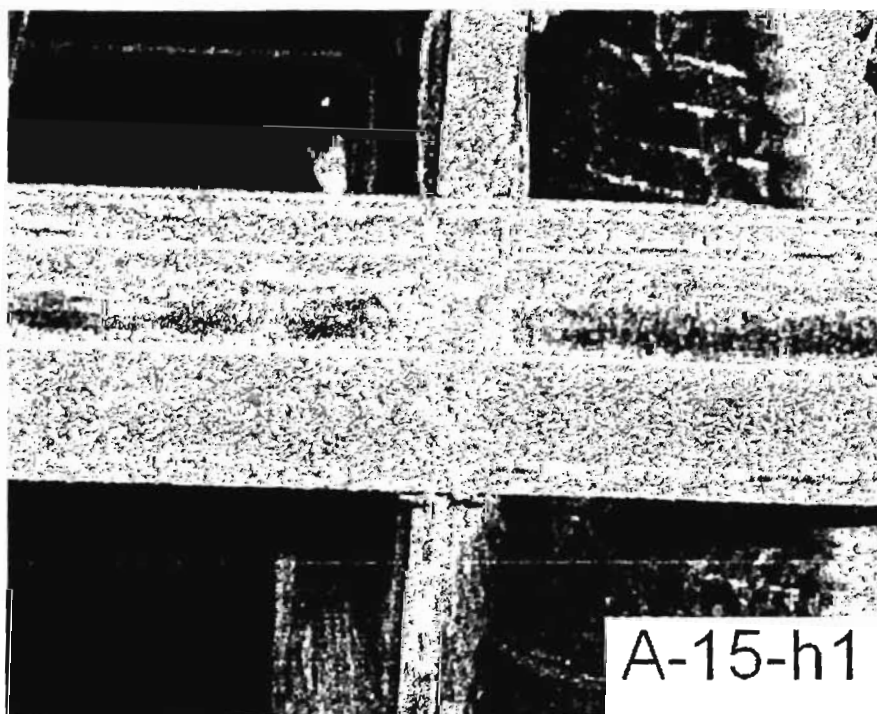
Photos 'h' and 'h1': Wire was tied around the support framing hat channel which led to a 'wavy/uneven' sheetrock installation on the ceilings. The close-up 'h1' shows a detail of the wire.

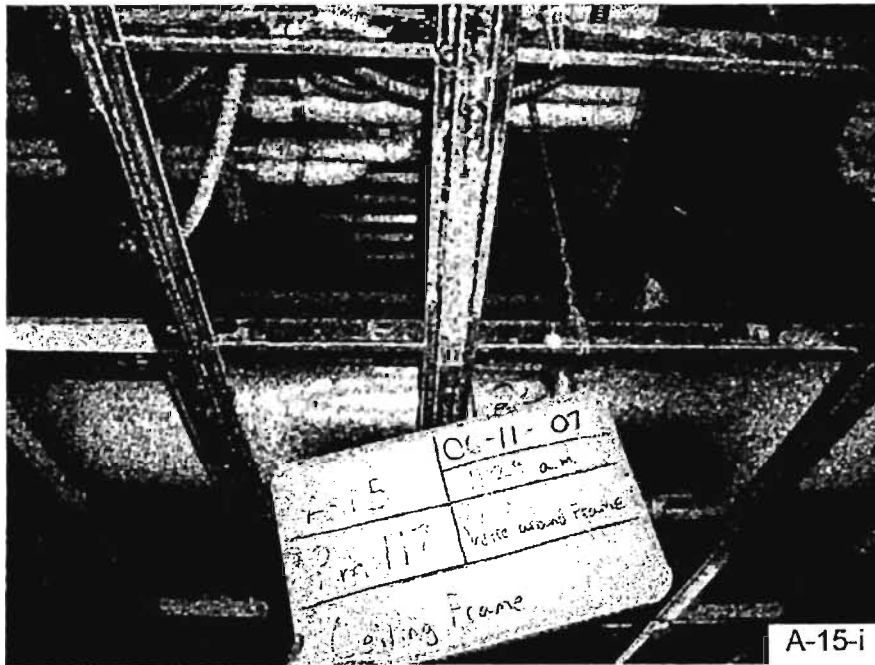
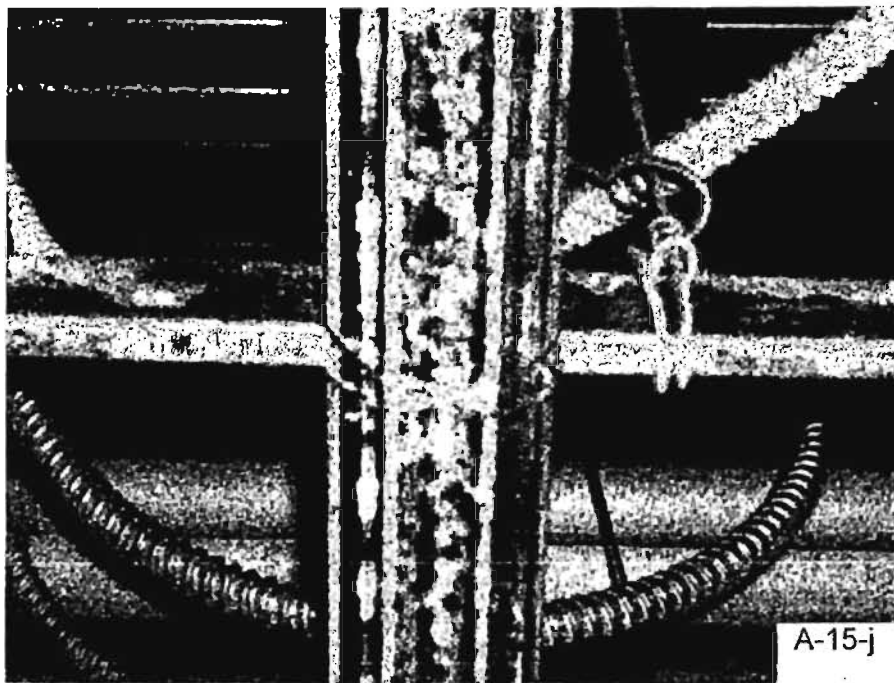
Photos 'i' and 'j': Wire was tied around the support framing hat channel which led to a 'wavy/uneven' sheetrock installation on the ceilings.

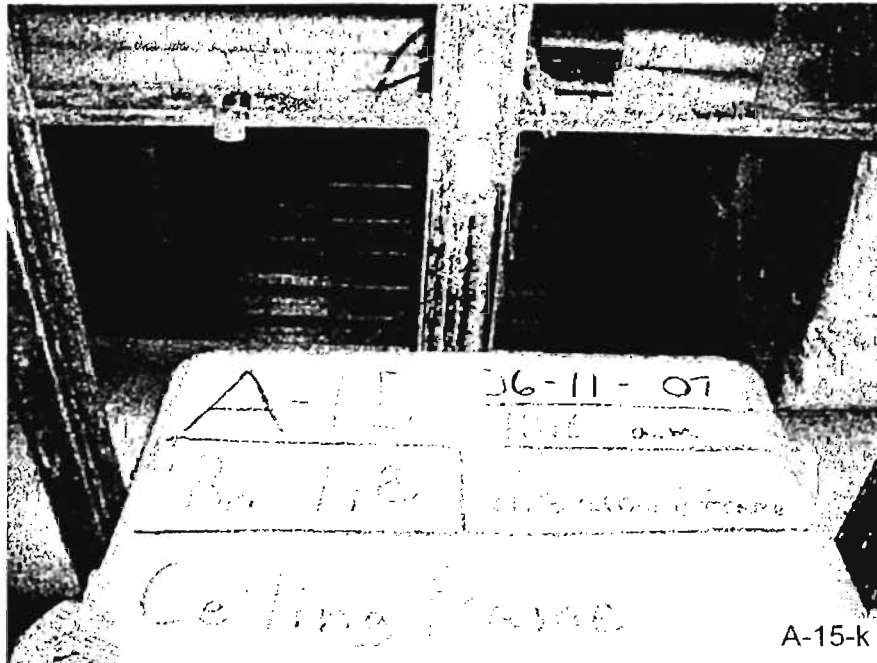
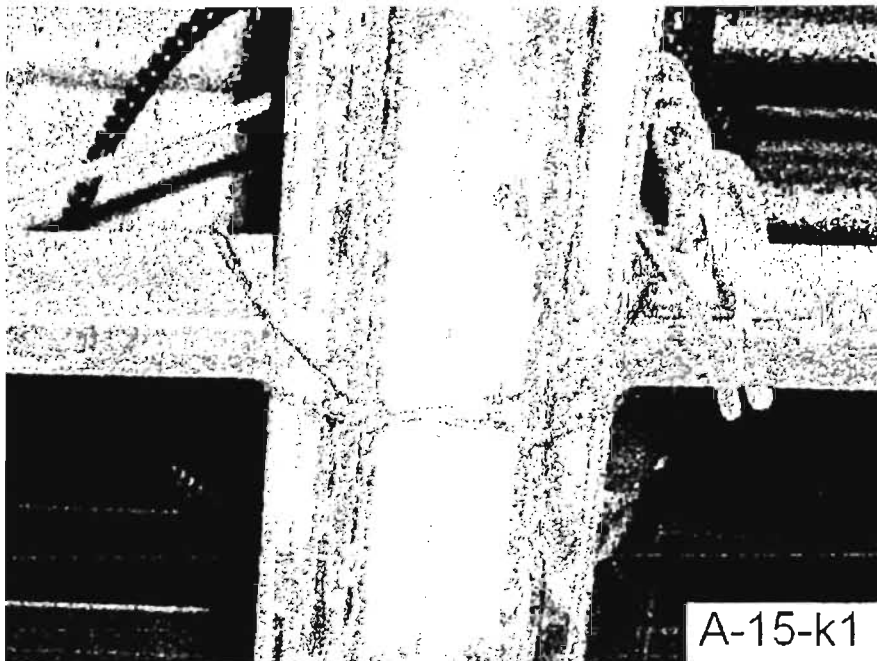
Photos 'k' and 'k1': Wire was tied around the support framing hat channel which led to a 'wavy/uneven' sheetrock installation on the ceilings. The close-up 'k1' shows a detail of the wire.

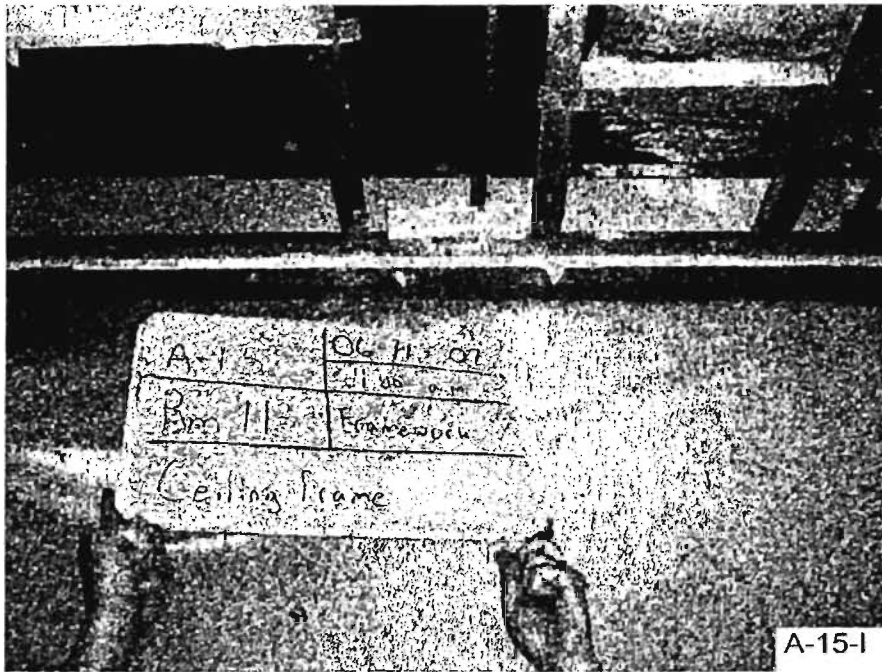
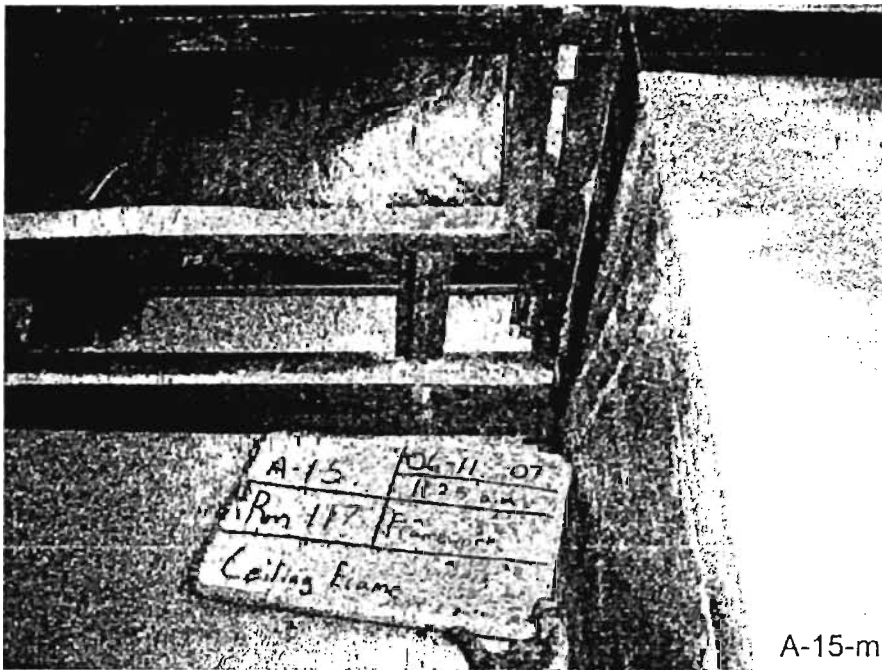
Photos 'l' and 'm': Photos indicate frame workmanship.

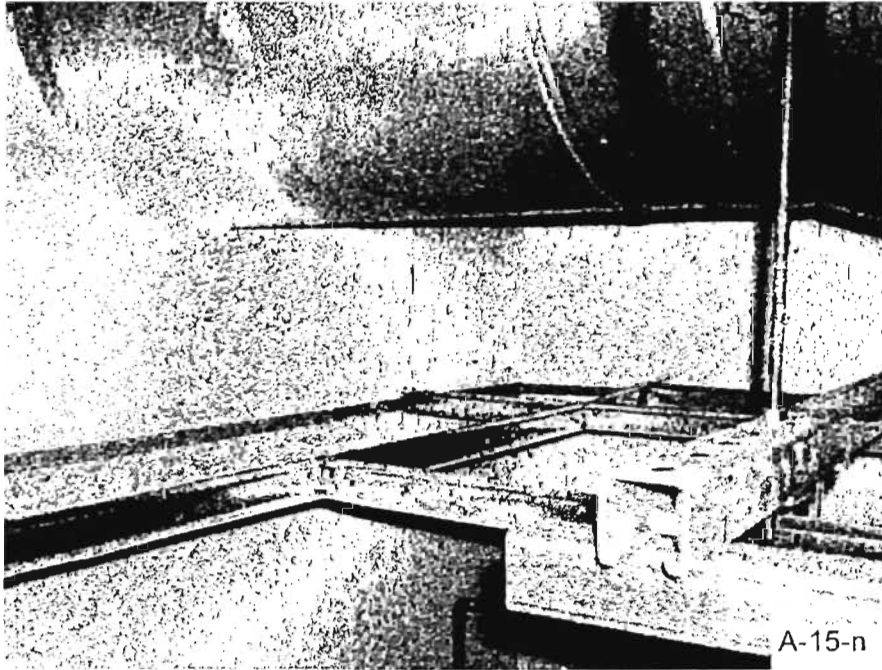
Photo 'n': Photo of frame workmanship in the Northwest corner of Room 117(no support wiring installed at suspended ceiling).

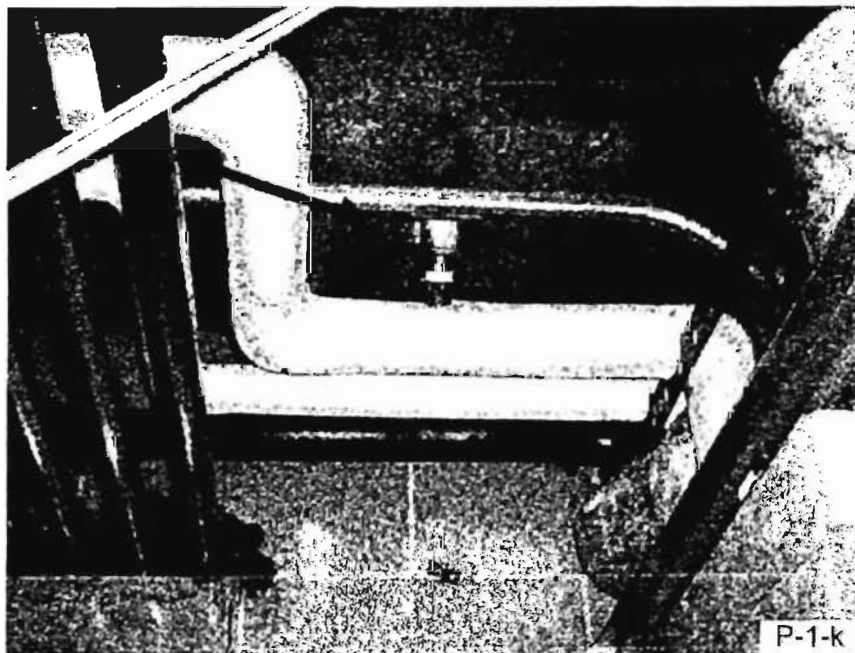
P-1-j

Photos 'j' and 'k': The water hammer arrestors above the ceiling were not accessible.  
Room 110.

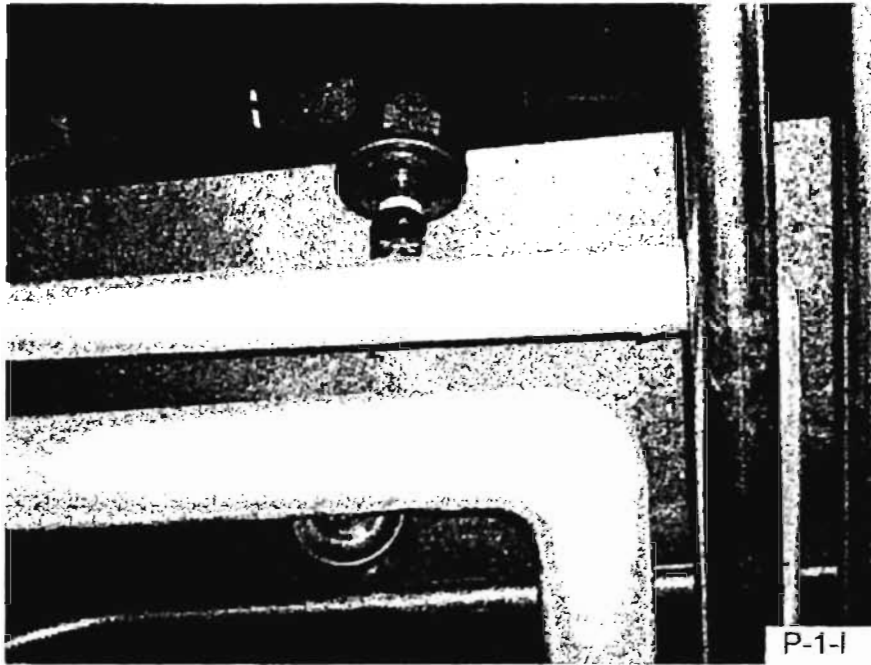
Photo 'I': The water hammer arrestors above the ceiling were not accessible. Room 110

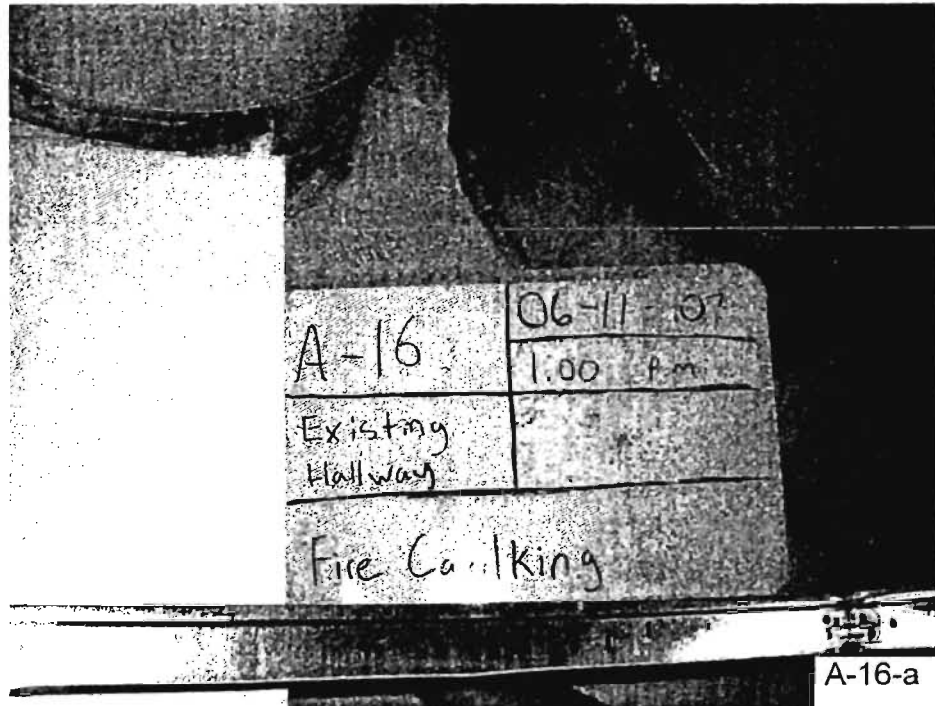
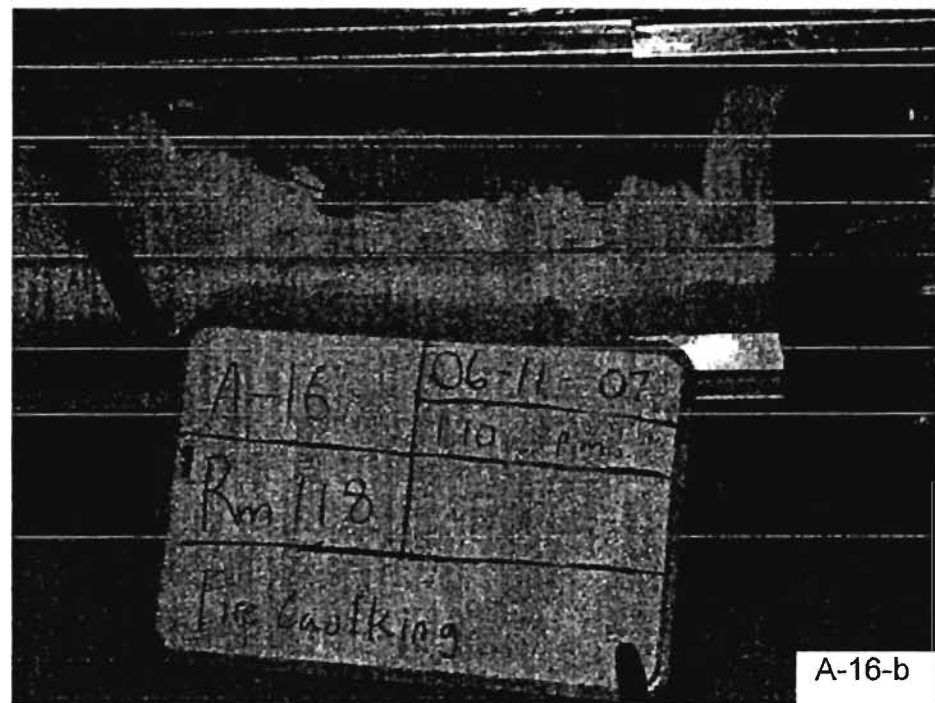
Photos 'a' and 'b': Ventilation ducts that were fire caulked. (Photo 'a' on West wall above the autoclave in Corridor 121, photo 'b' on East wall above the Baker cabinet).

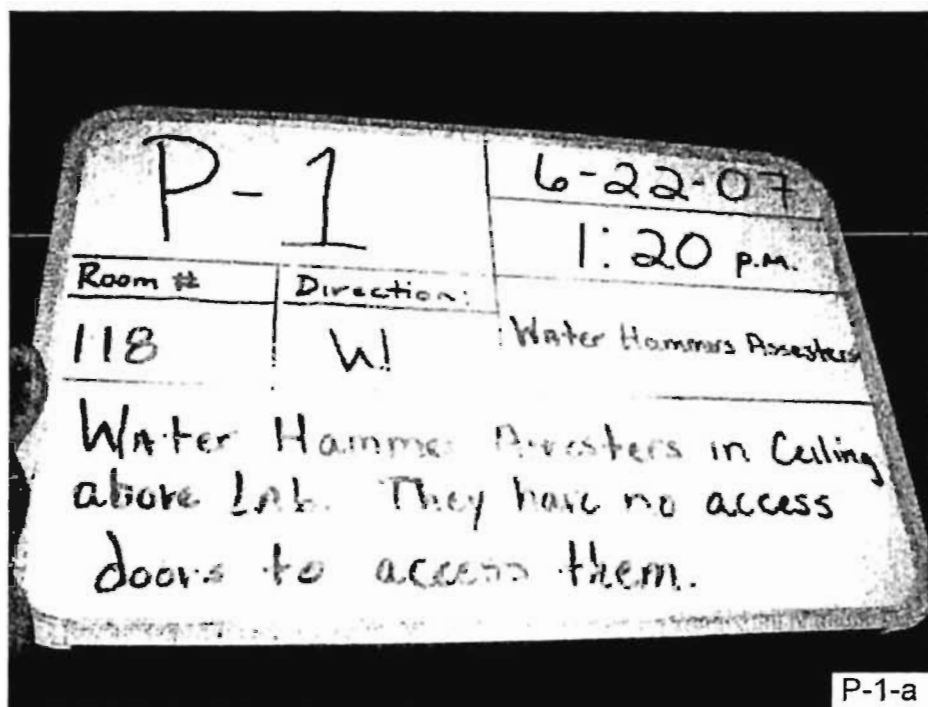
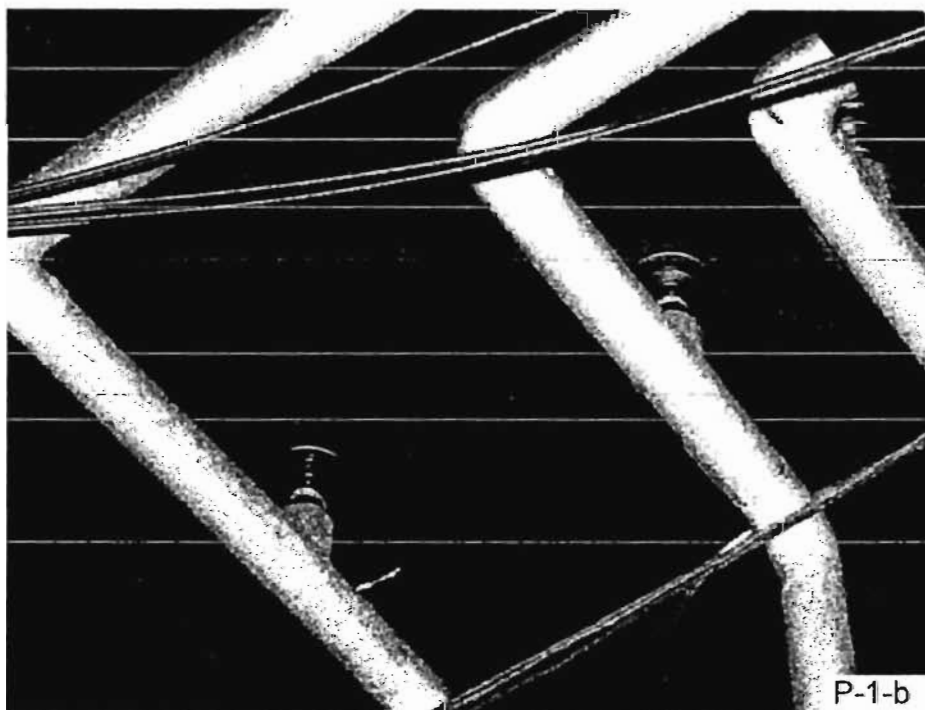
These pictures depict the water hammer arrestors in different rooms of the Laboratory spaces. They were above a hard lid and were not accessible through access doors (arrestors require access). The pictures were taken after the ceiling had been removed.

Photos 'a' and 'b': The water hammer arrestors above the ceiling were not accessible.

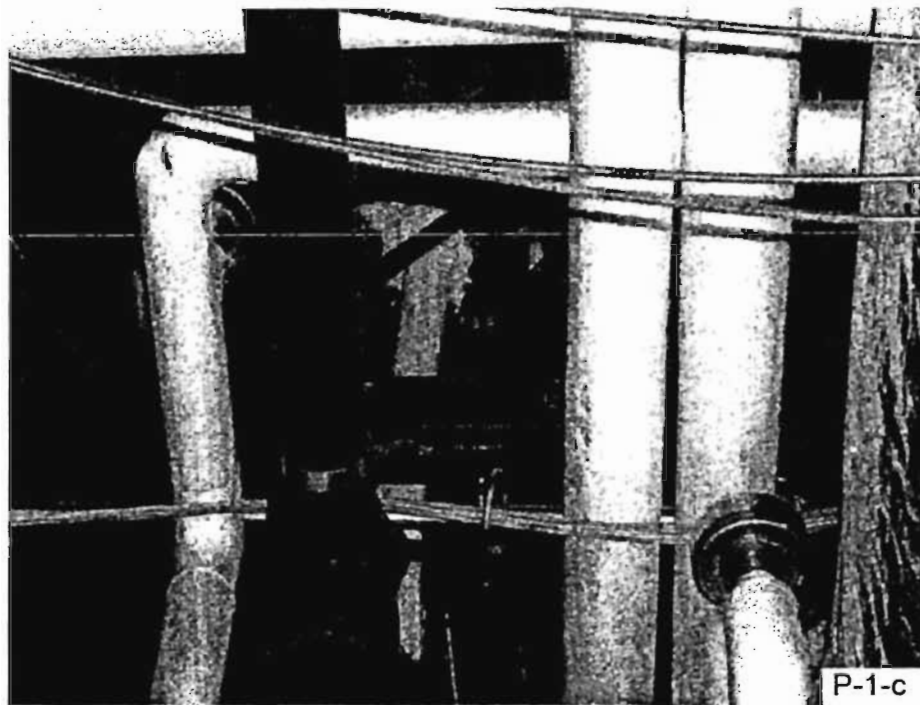
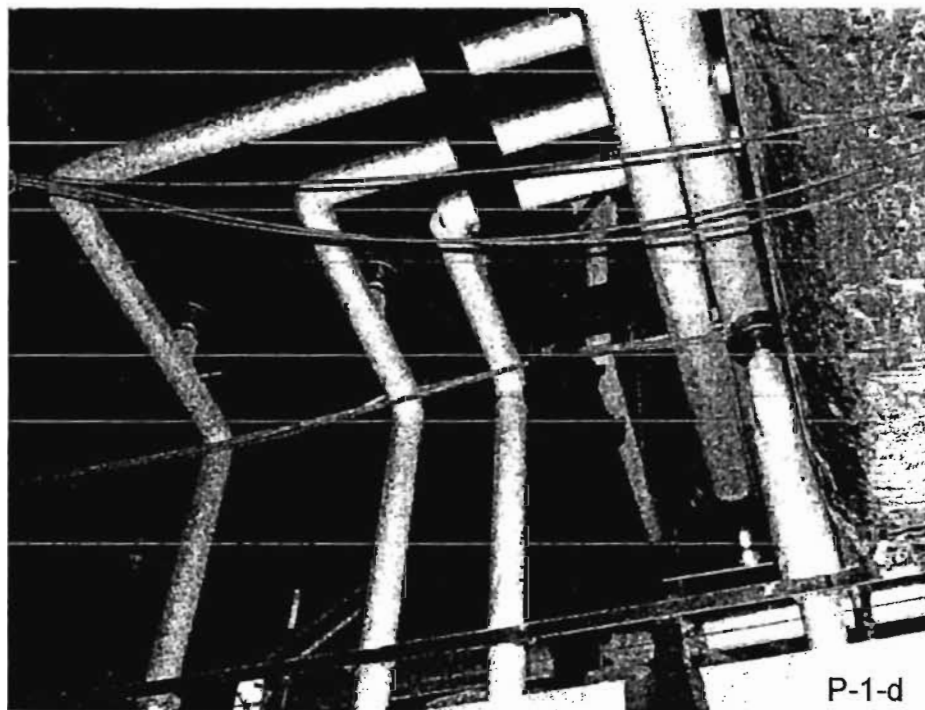
Photos 'c' and 'd': The water hammer arrestors above the ceiling were not accessible.  
Room 118.

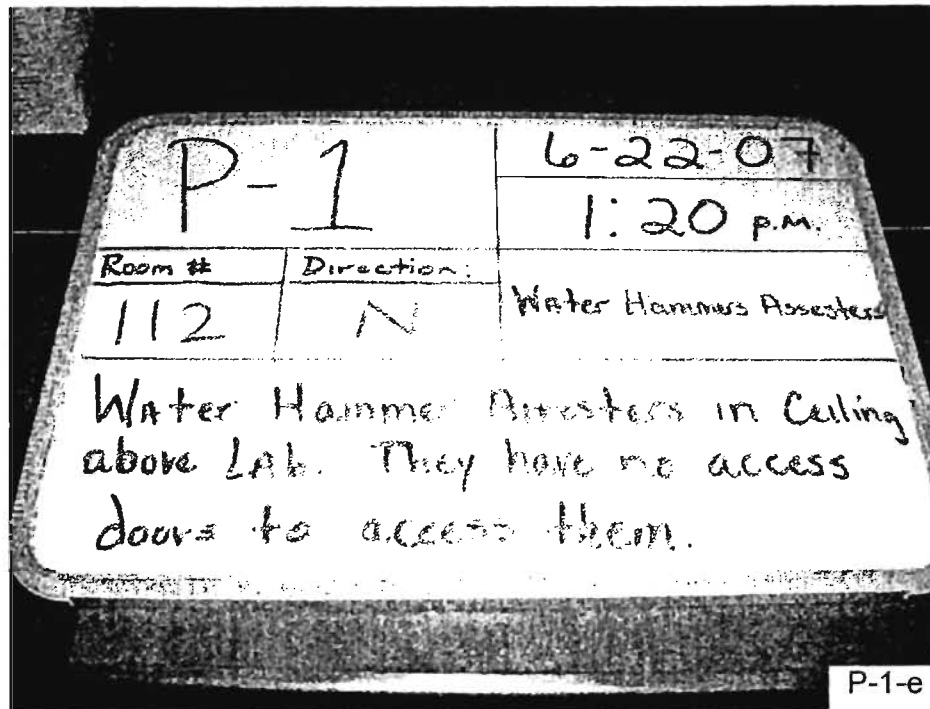
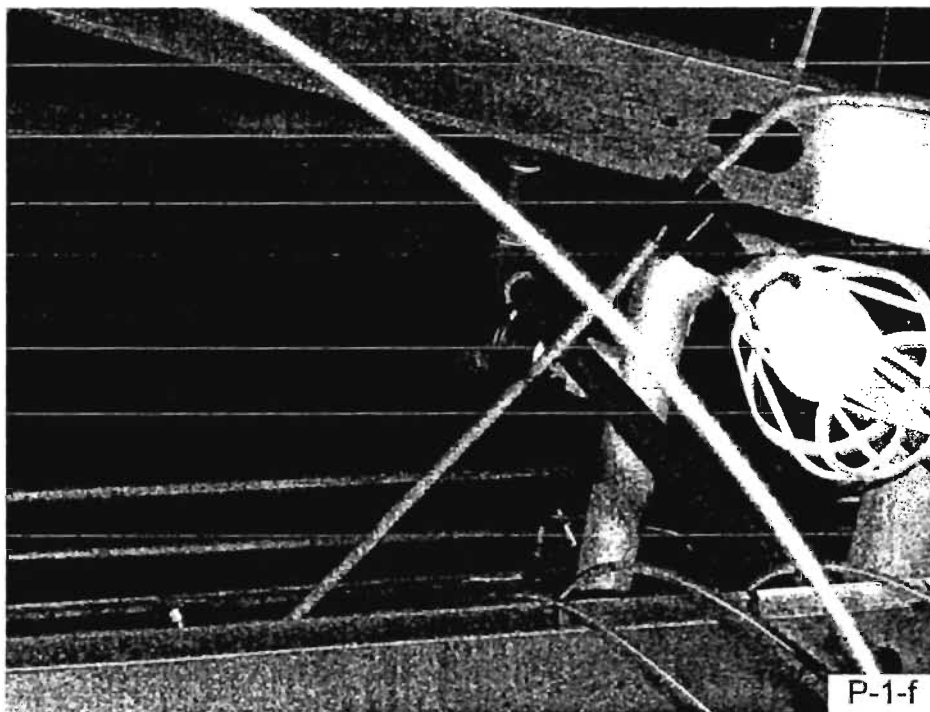
Photos 'e' and 'f': The water hammer arrestors above the ceiling were not accessible.

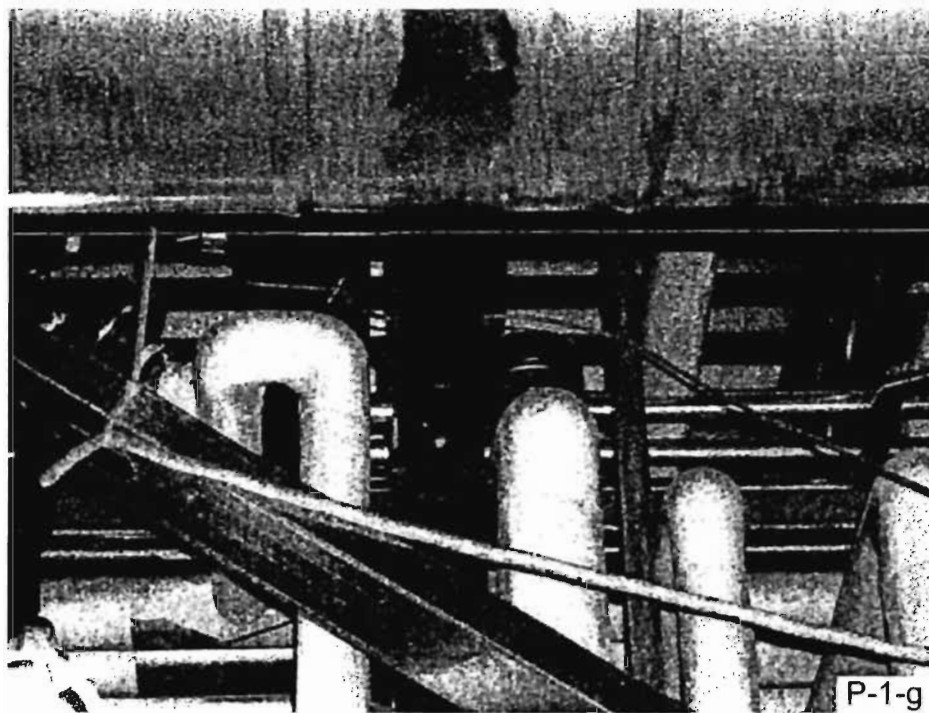
Photo 'g': The water hammer arrestors above the ceiling were not accessible. Room 112.

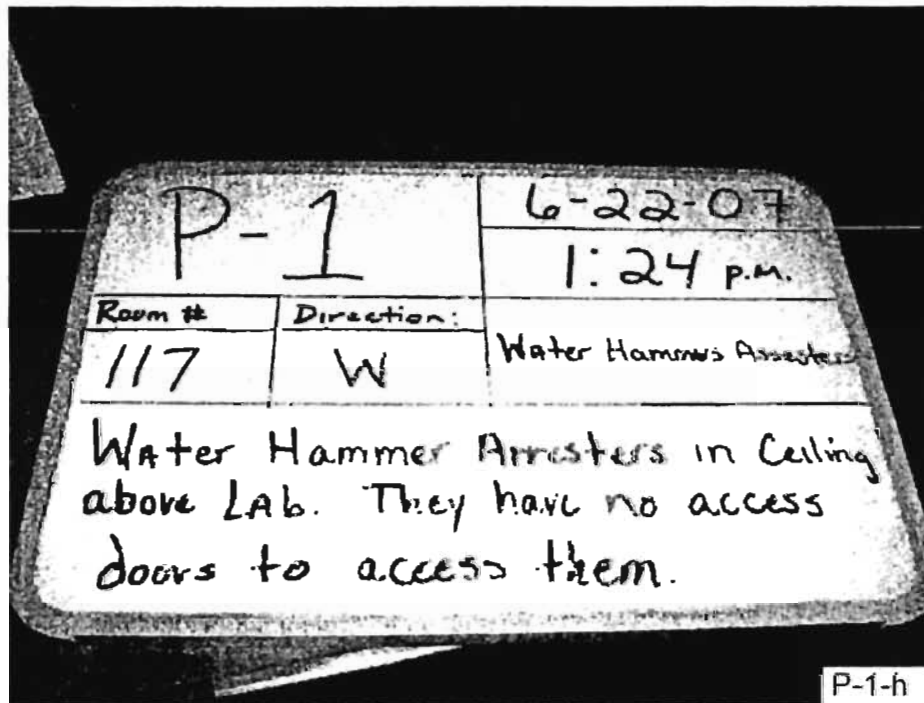
Photos 'h' and 'i': The water hammer arrestors above the ceiling were not accessible.

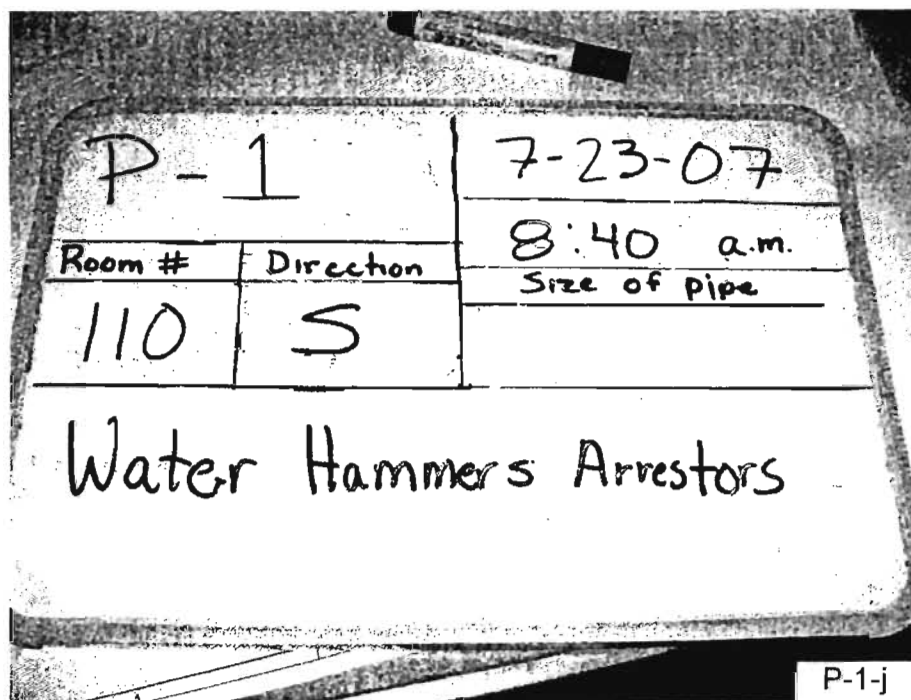
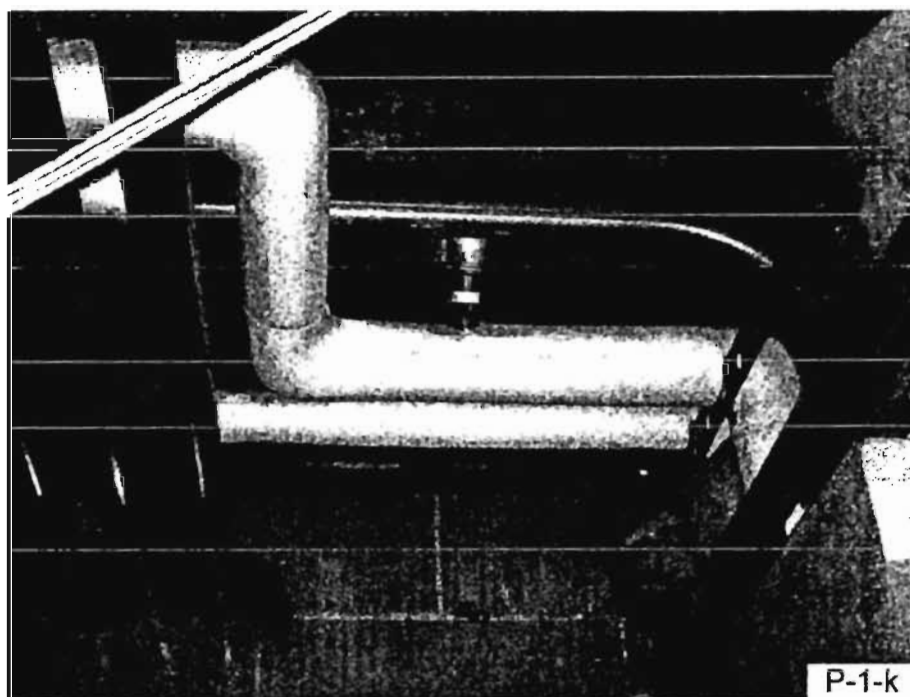
Photos 'j' and 'k': The water hammer arrestors above the ceiling were not accessible.

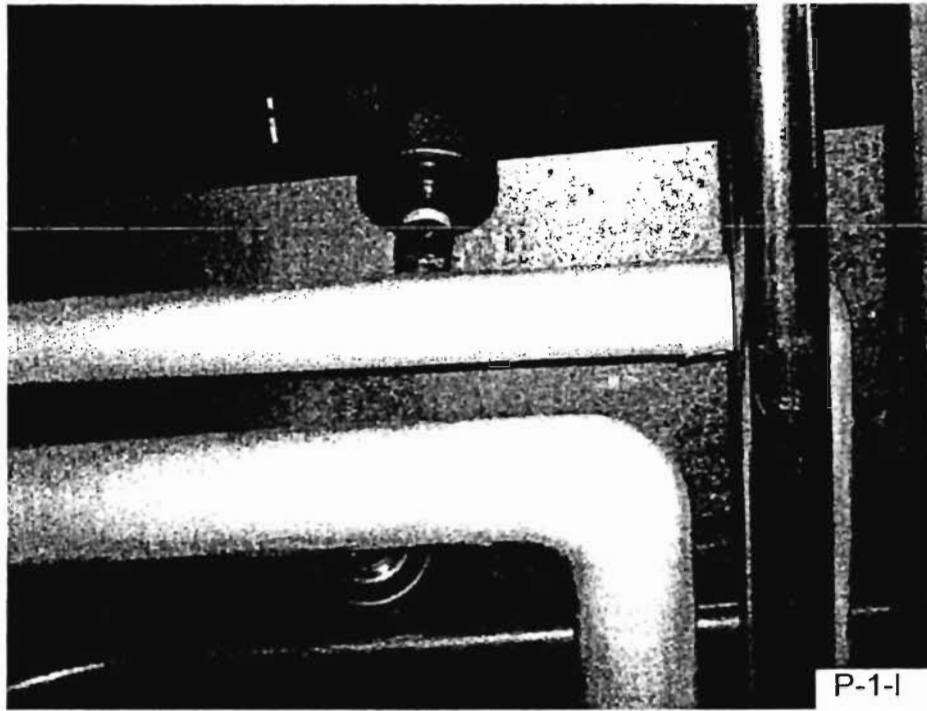
Photo 'P': The water hammer arrestors above the ceiling were not accessible.

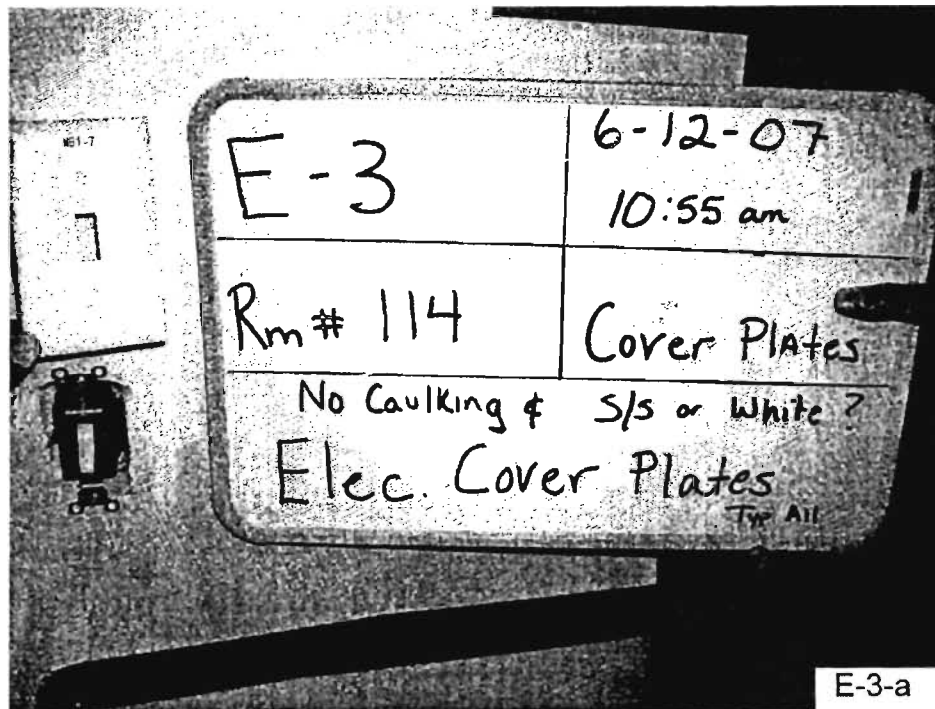
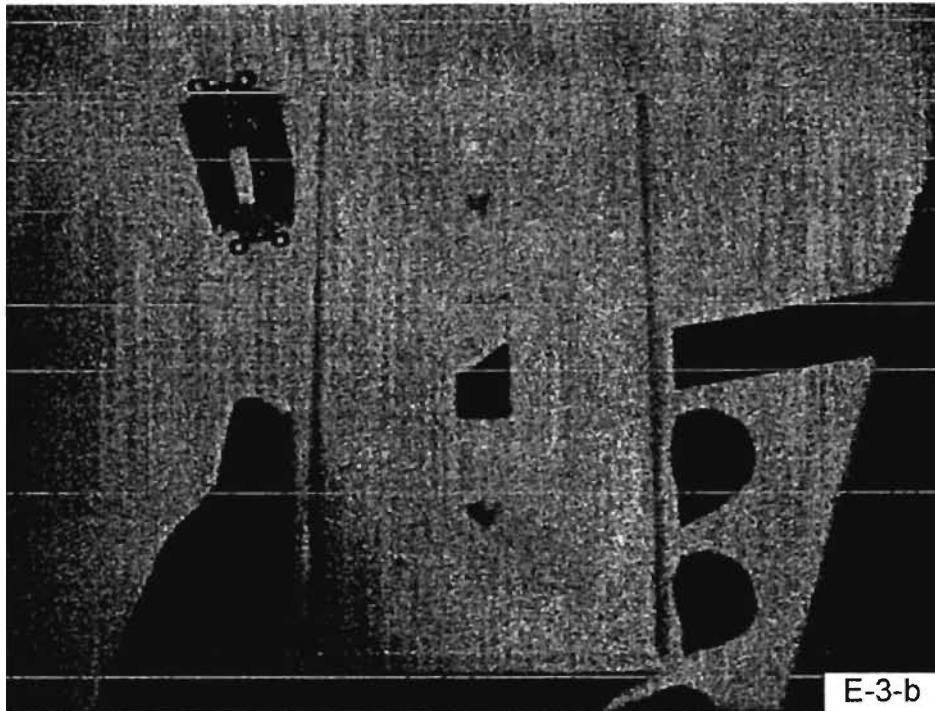
Photos 'a' and 'b': Light switch cover plates were not caulked per Specification 16511, 3.1A, per Addendum #1 (E). Also, the cover plates were not metal per Specification 16140, 2.4A.
